ENGINEERING GEOLOGY ASSESSMENT OF
SLOPE INSTABILITY ON FOREST LANDS
IN SOUTH WESTLAND

A thesis
submitted in partial fulfilment
of the requirements for the Degree
of
Master of Science in Engineering Geology
in the
University of Canterbury
by
MARK J EGGERS

University of Canterbury
1987

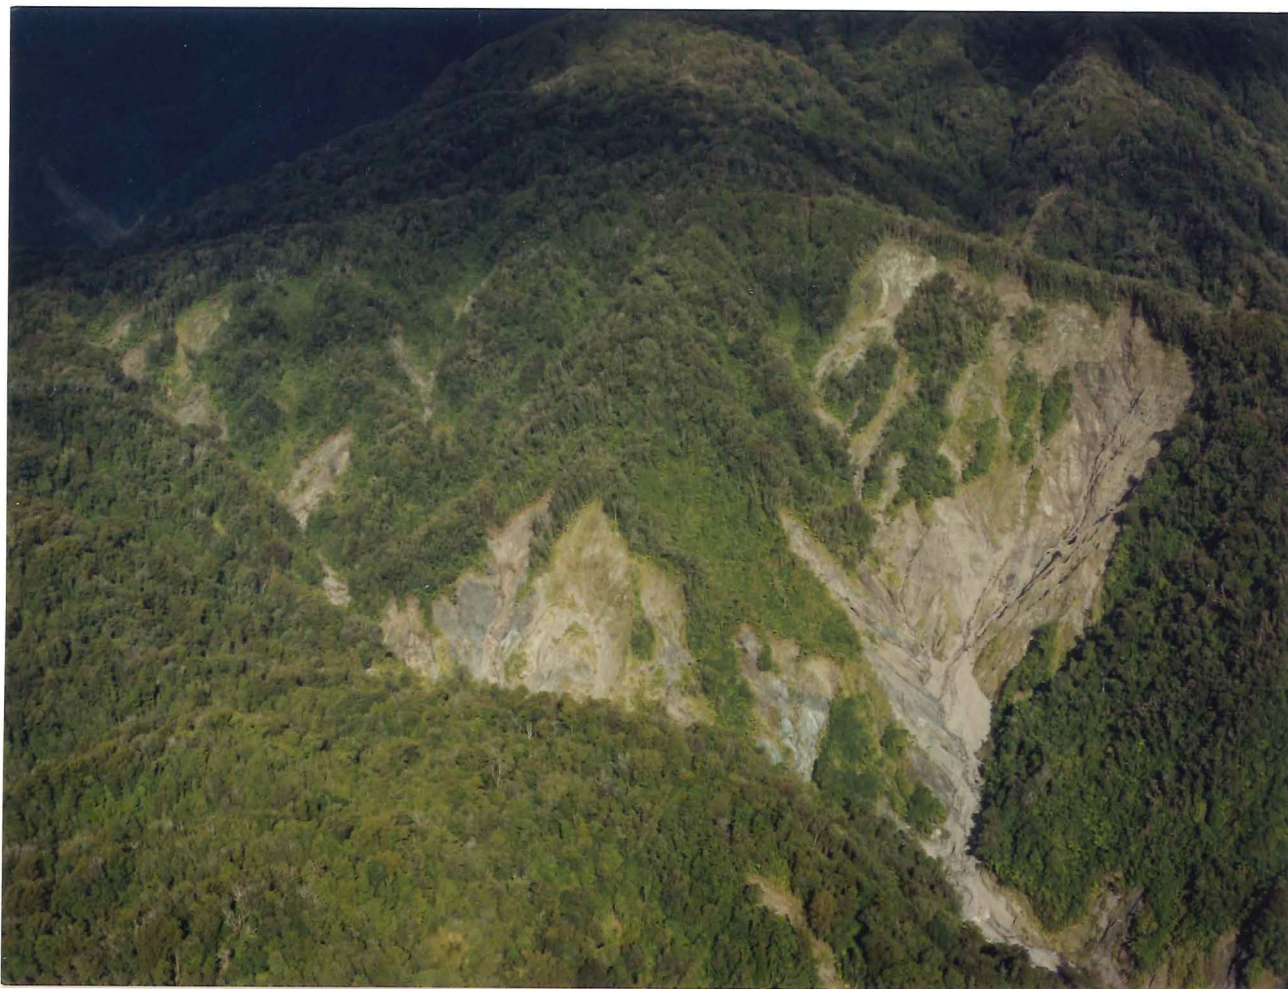
Fig. 5.1 Havelock Creek study catchment showing the large (240m vertical elevation) rock slide and other slope movements in the Alpine Fault Zone. Oblique view looking southeast.
(N.Z. Geological Survey photo CN 5824a, photographer: D.L. Homer)

The most dominant morphological feature in the study site is a vertical 240m high slope movement scar up the left branch (Fig. 5.1). This failure has a 10-30m high headscarp which extends along the top of the ridgeline for approximately 350m, and gully erosion on the southwestern flank has removed a substantial amount of crushed schist bedrock leaving a sharp ridge-gully topography. The northeastern flank is separated into two blocks by a major scarp, the lower block undergoing active gully erosion while the upper block still supports the original forest vegetation cover, with incipient slope storage-infilled gullies developing on the surface (perhaps signifying future erosion potential). Average slope angle of this displaced block is 40°, while adjacent slopes average 38°.

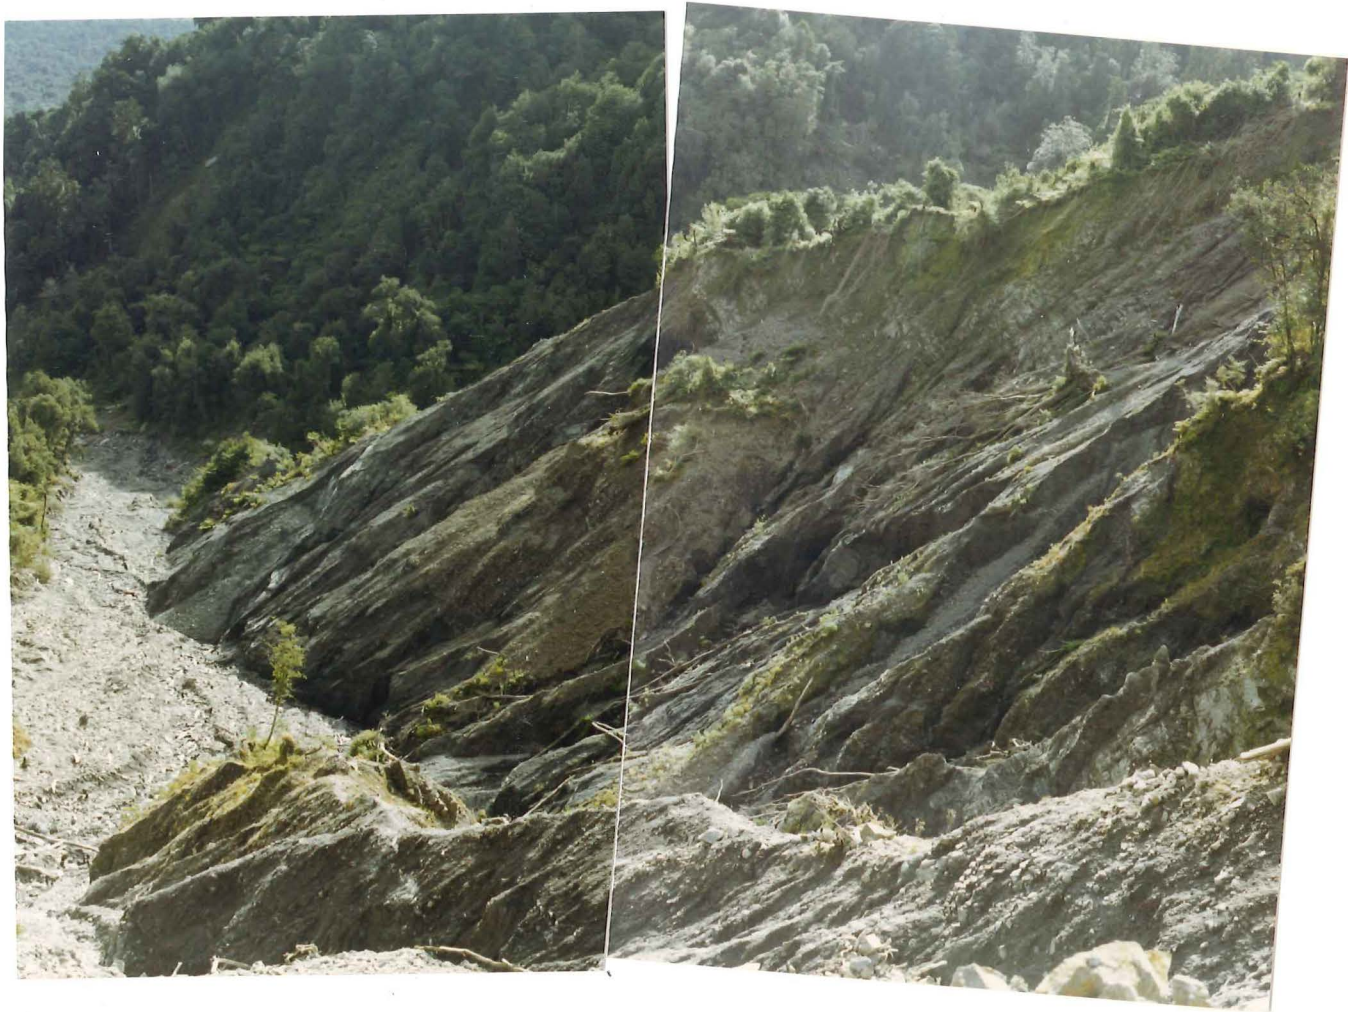
Throughout the rest of the catchment both fresh and eroding escarpments, resulting from slope failure and gully erosion, form the most obvious surface morphological features (Fig. 5.5). These are often mantled at the base of the slope by debris accumulation deposits in the form of debris fans. All these features have been mapped on the 1:2000 engineering geology plan (Fig. 3, map pocket).

Fig. 5.5 Gully erosion on escarpment slope in crushed mylonite schist bedrock at locality HE 5.

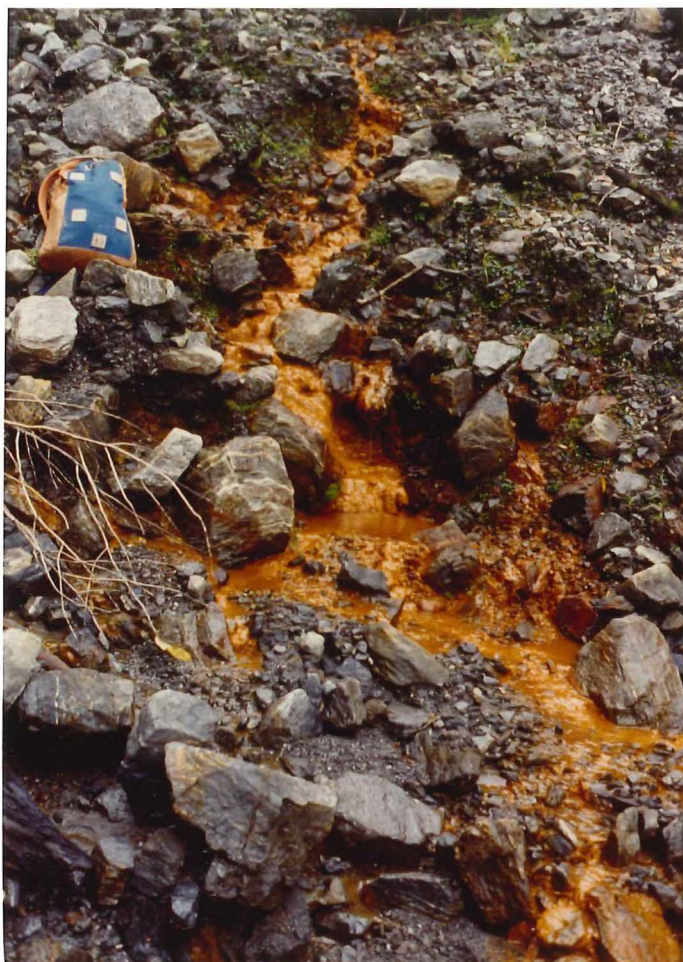
Numerous cold water mineral springs which occur in the catchment are characterised by a brownish yellow precipitate deposited on surrounding rocks and a pungent "rotten egg" smell indicating hydrogen sulphide (H_2S) gas (Fig. 5.6). Similar cold water H_2S mineral springs have been noted elsewhere within the Alpine Fault Zone in South Westland. These springs are thought to originate from deep-reaching circulating groundwater which is heated by frictional mechanisms, dissolving mineral material from surrounding country rock. These solutions travel to the surface along the line of weakness provided by the fault plane, decreasing in temperature and becoming cold (similar temperature to stream water) by the time they reach the surface.

Fig. 5.6 Cold water H_2S spring depositing a brownish yellow precipitate on surrounding stream gravels at Havelock Creek.

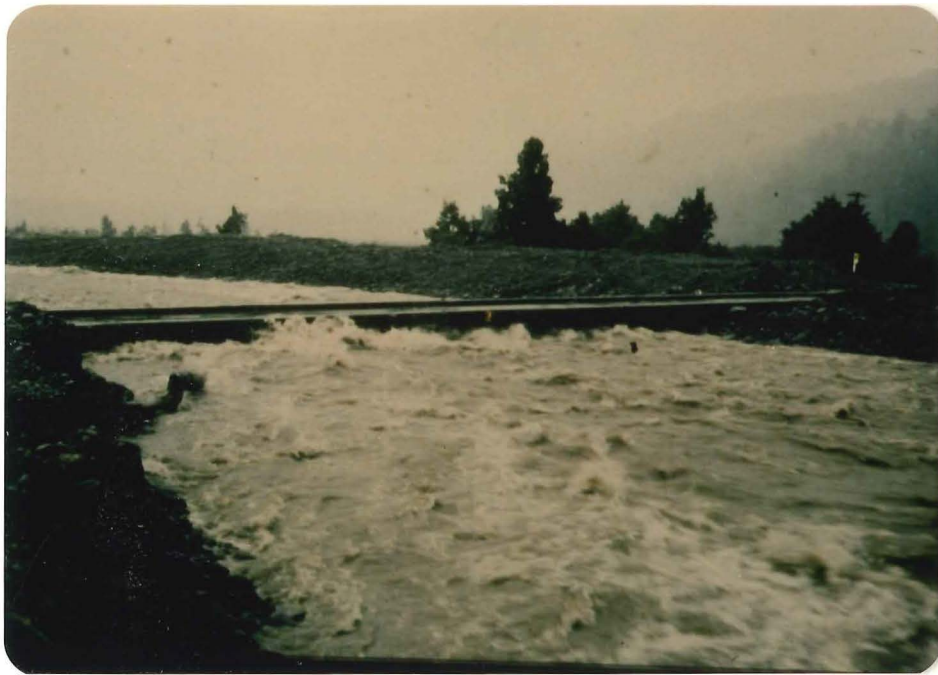
which is situated on the Havelock Creek alluvial fan. During times of high flow (Fig. 5.7), substantial quantities of sediment are being transported on to the fan surface threatening the bridge crossing in two ways:-

Fig. 5.7 State Highway 6 bridge crossing of Havelock Creek minutes after flood waters passed over the concrete slab structure, flooding the bridge decking.

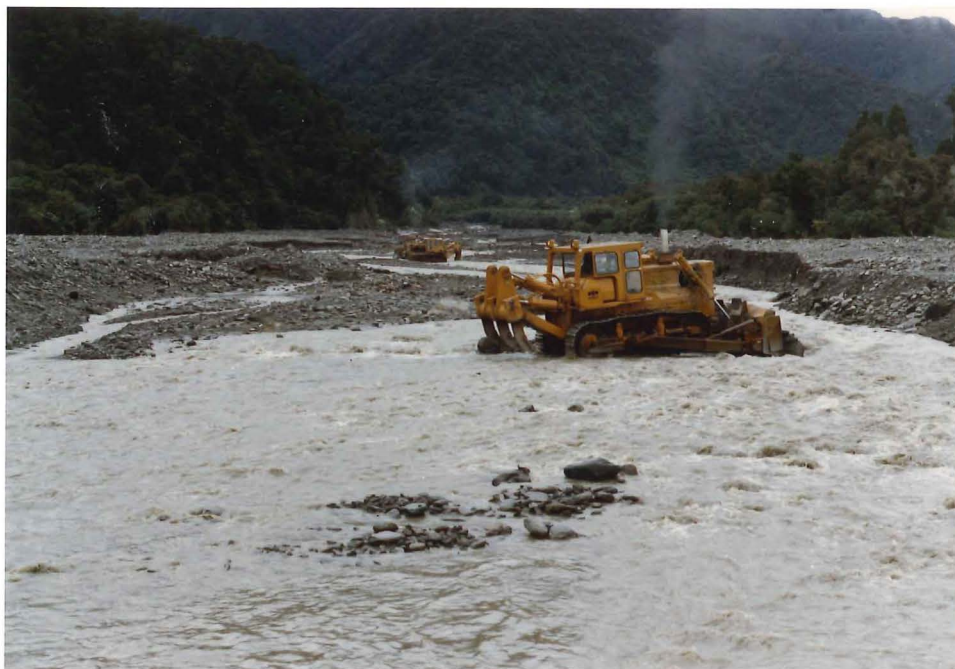
Fig. 5.8 Bulldozers clearing and realigning the stream channel to flow through the bridge waterway opening at Havelock Creek after a major fresh.

1. grooming the stream channel on the alluvial fan surface to direct the flow through the waterway opening (Fig. 5.8);
2. constructing uncompacted gravel levees where flood channels have deviated away from this straight course, and;
3. clearing the bridge waterway opening after each major fresh and flood.

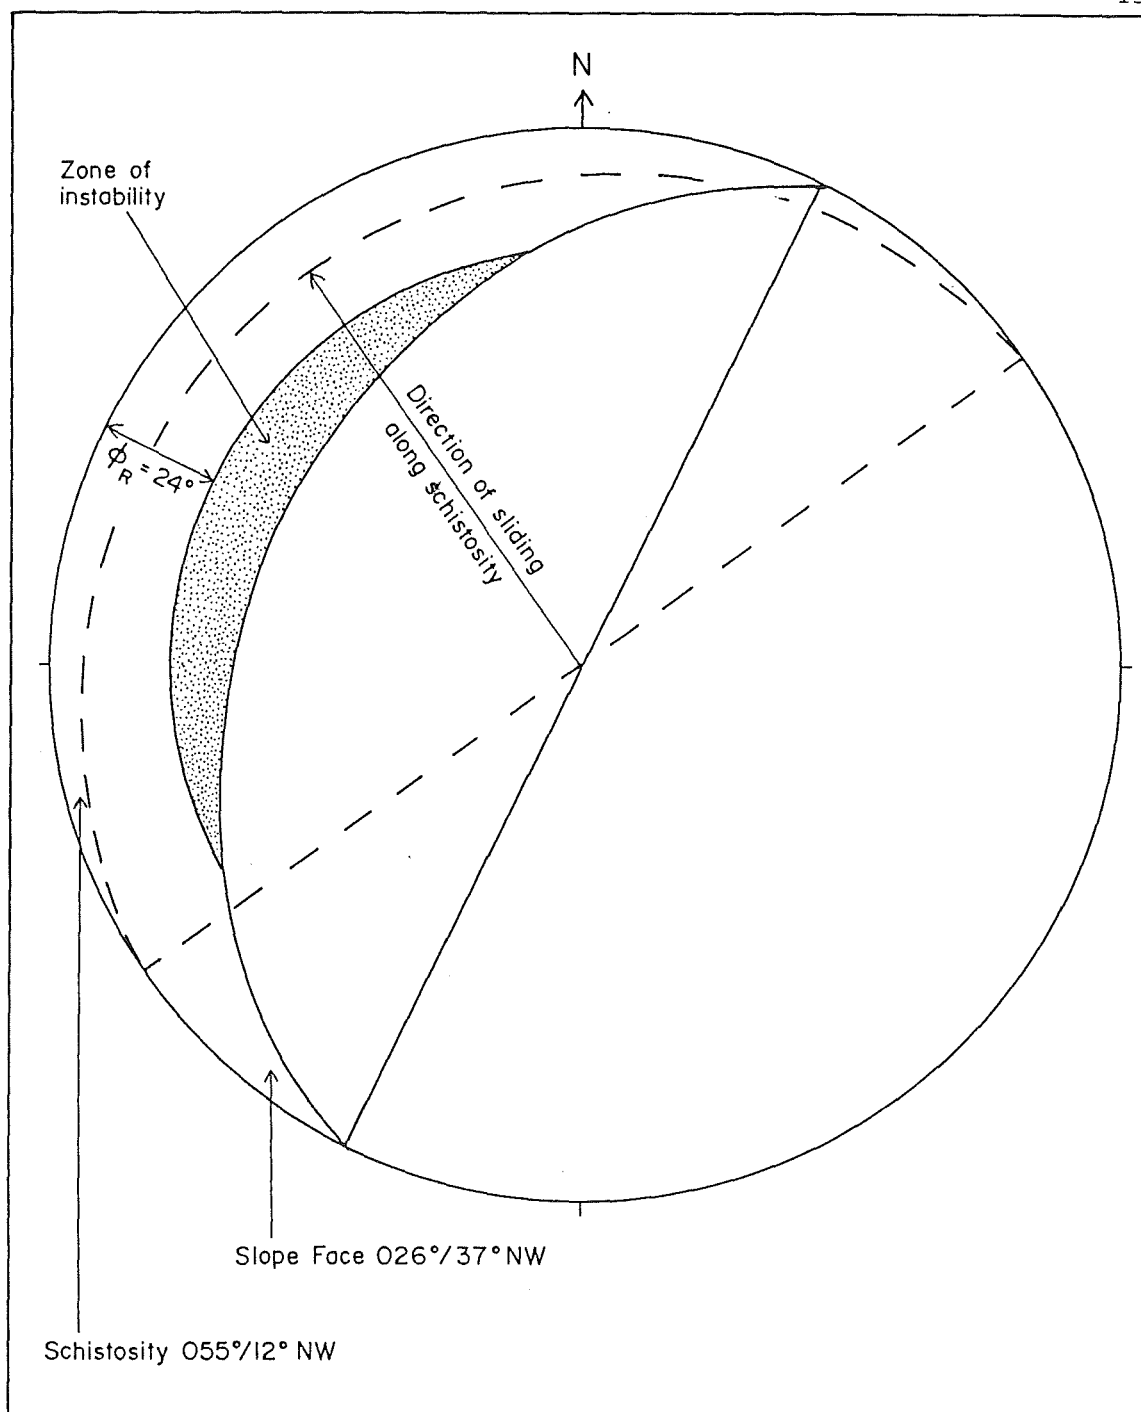
Fig. 5.13: Stereoplot of rock block slide at locality HE6, Havelock Creek

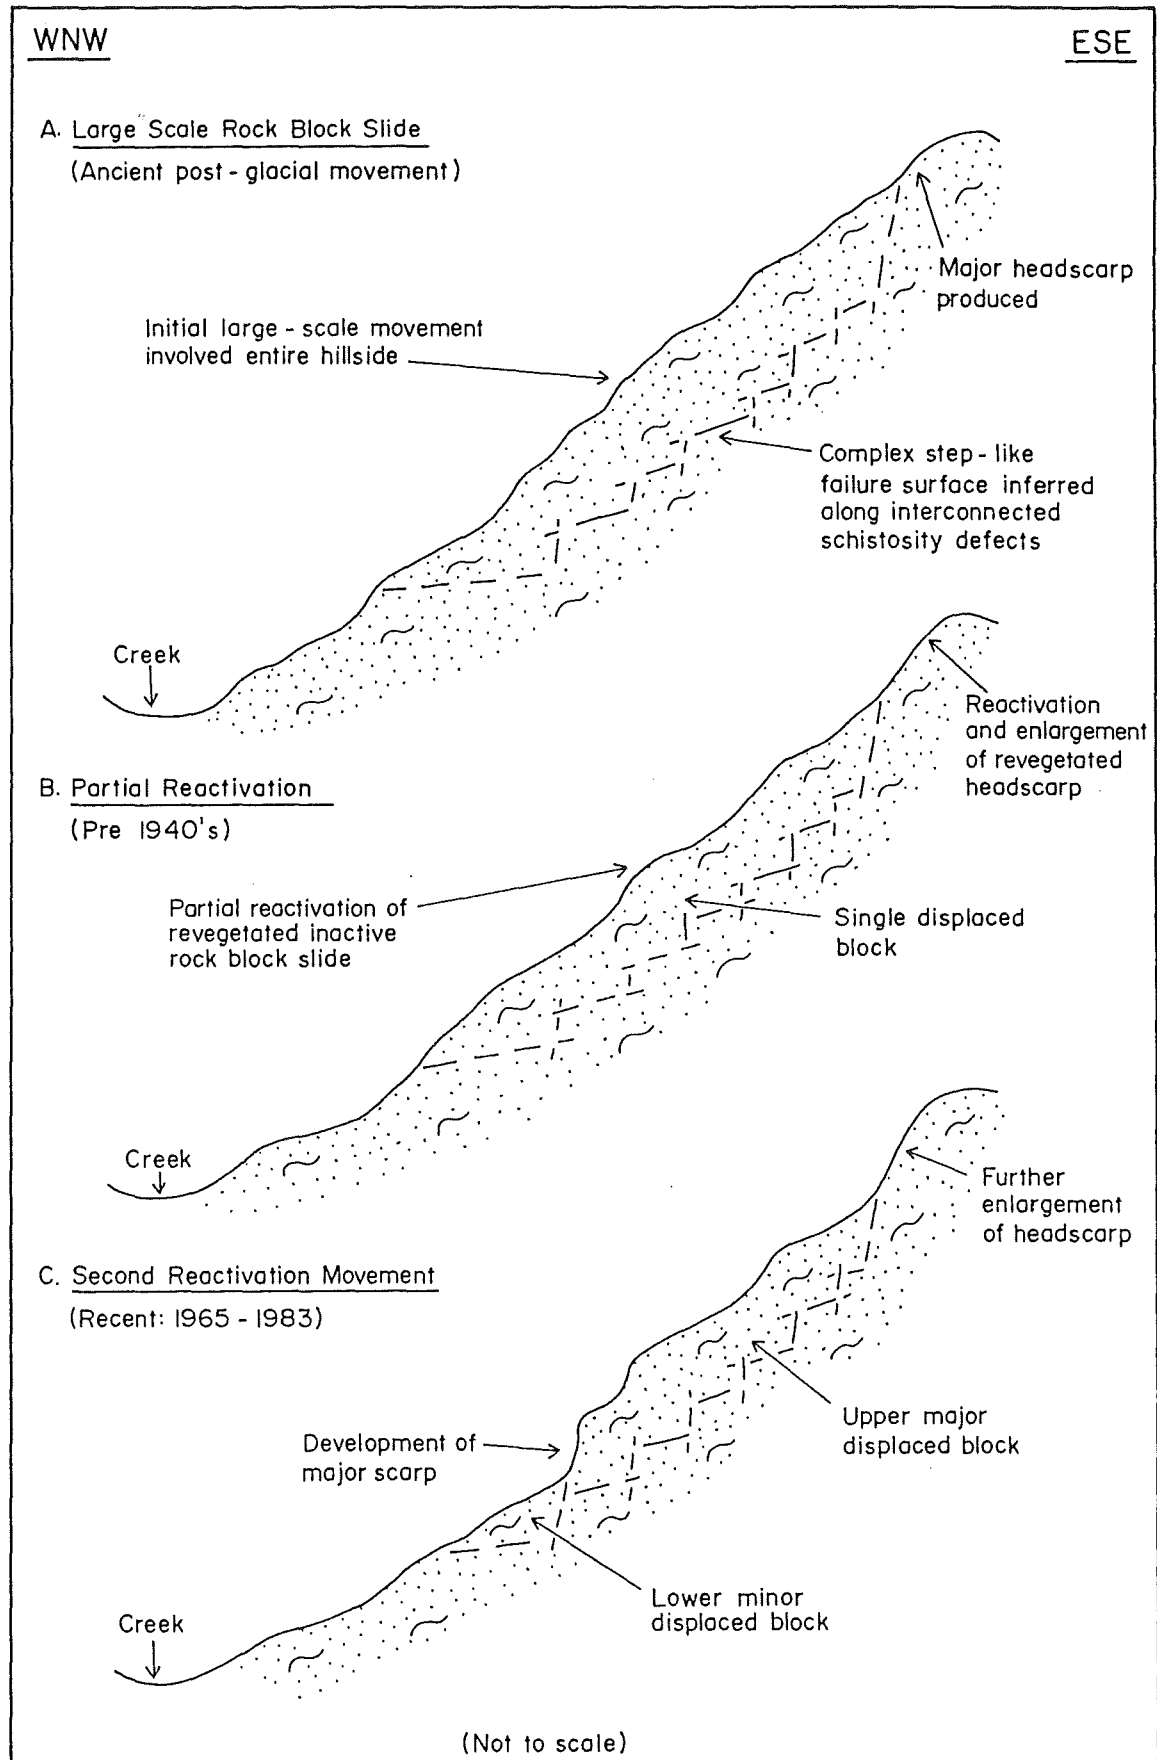
Limited evidence can be obtained from aerial photograph interpretation as to the history of movement. 1942 photography (Appendix 4 details aerial photograph coverage of Havelock Creek) clearly shows in outline the present area of the landslide scar with a headscarp which does not seem to be as fully developed as is currently. No major scarp is visible, the landslide being comprised of a single block, and limited erosion activity had taken place on the western flank. A lineament, extending southwestwards from the headscarp just below the top of the ridgeline almost to Havelock Creek (see Fig. 4, map pocket), can be identified below which is an area of depressed topography. 1965 photography shows the landslide scar to be fully vegetated, although the headscarp and lineament are still discernible. 1983 coverage shows the present day situation with the fully developed headscarp, the major scarp, and the eroding western flank.

Fig. 5-14: Sketch diagram illustrating movement history of rock block slide in crushed normal schist at locality HE 6, Havelock Creek

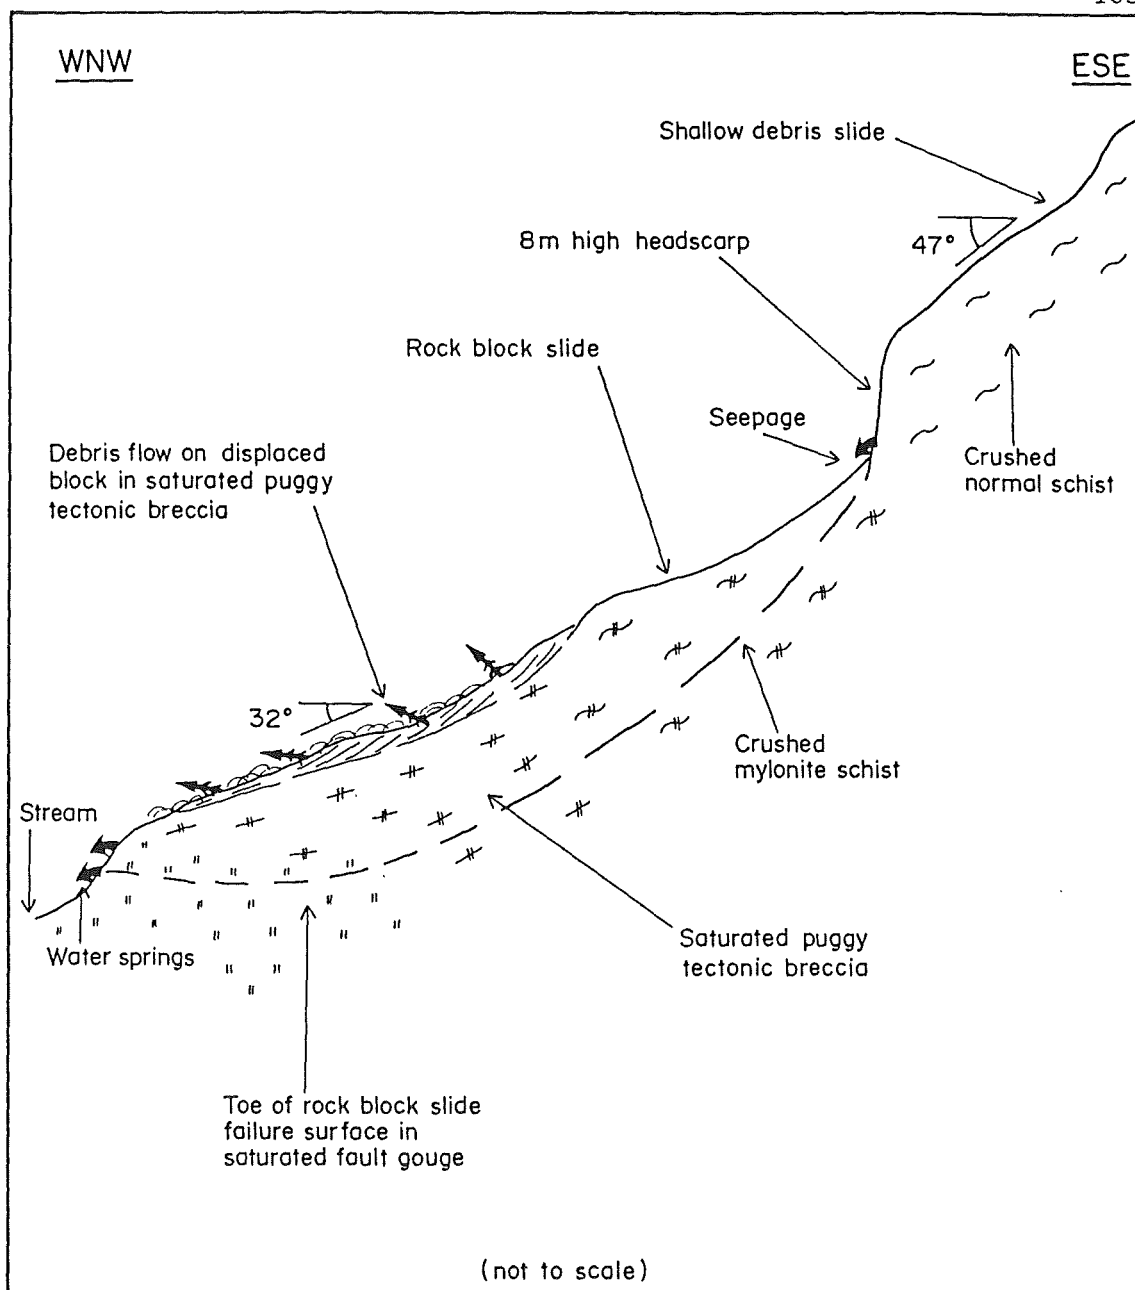
Fig. 5-15: Sketch diagram illustrating rock block slide in crushed mylonite schist and debris flow in puggy tectonic breccia at locality HE9, Havelock Creek

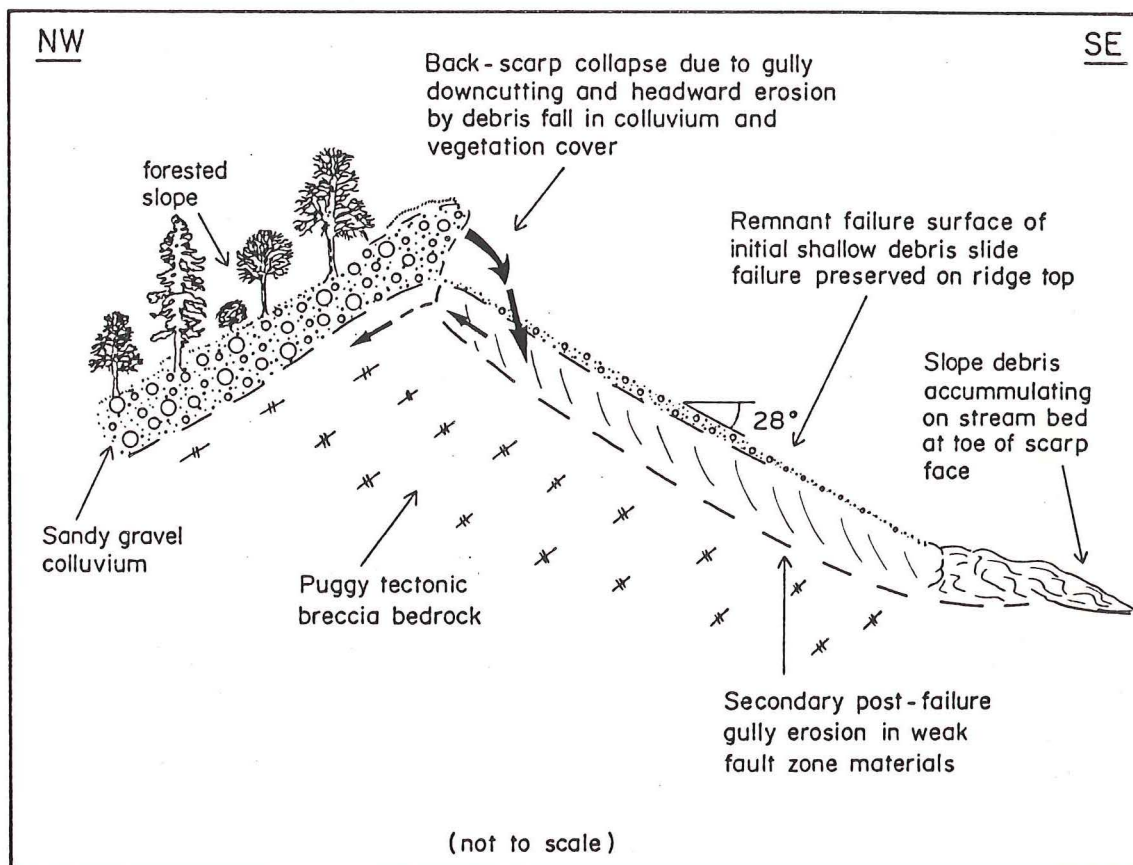
At locality HE 2 a 150m long scarp has developed in puggy tectonic breccia which has been dissected by post-failure gully erosion (Fig. 5.16). Initial failure was by shallow sliding of the debris cover along the interface with underlying bedrock, and once this protective cover had been removed the underlying weak fault zone materials were exposed

Fig. 5.18: Sketch diagram of shallow debris slide and secondary post-failure gully erosion at locality HE 2, Havelock Creek

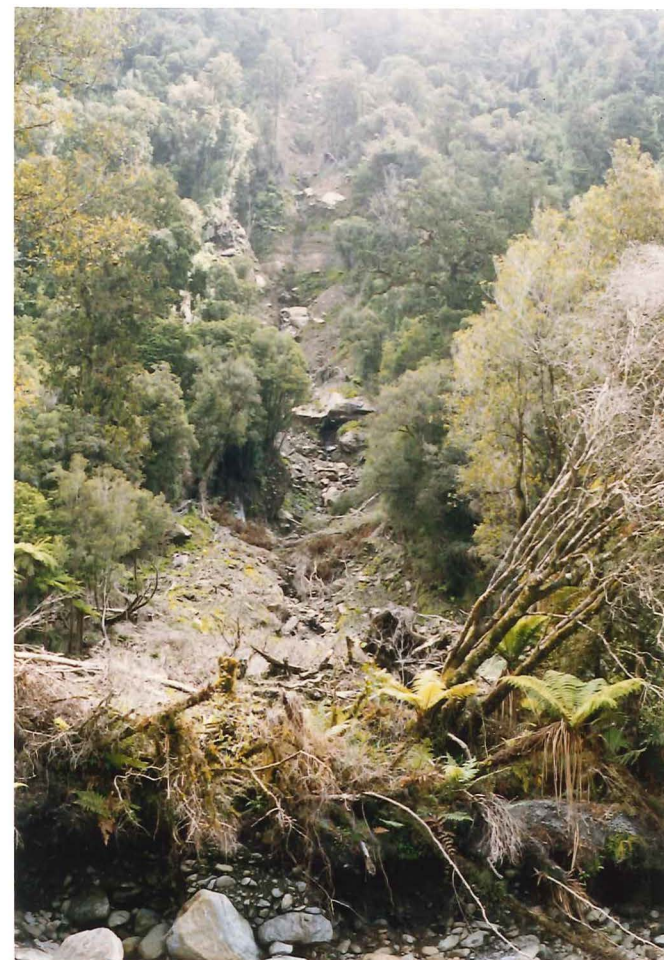
The debris slide-avalanche failures occur on both riparian slopes (up to approximately 70m above stream level) with the toe of the slide scar at stream level (Fig. 5.20), and on mid-slope positions where slide materials form debris torrents down to stream level (Fig. 5.21). Slope angles for these failures vary from 32 to over 45°, averaging around 38°. Failure commonly occurs in pre-existing gully depressions where water has accumulated, and sliding of the gully head wall region quickly degenerates into an avalanche-type movement due to the high water content of the slide debris and the steep, high slopes. Due to the high regional rainfall, secondary gully erosion rapidly degrades the failure scar, deepening and extending the scar surface.

Fig. 5.21 Debris torrent on approx. 120m high slope at Saltwater Creek in the Alpine Fault Zone.

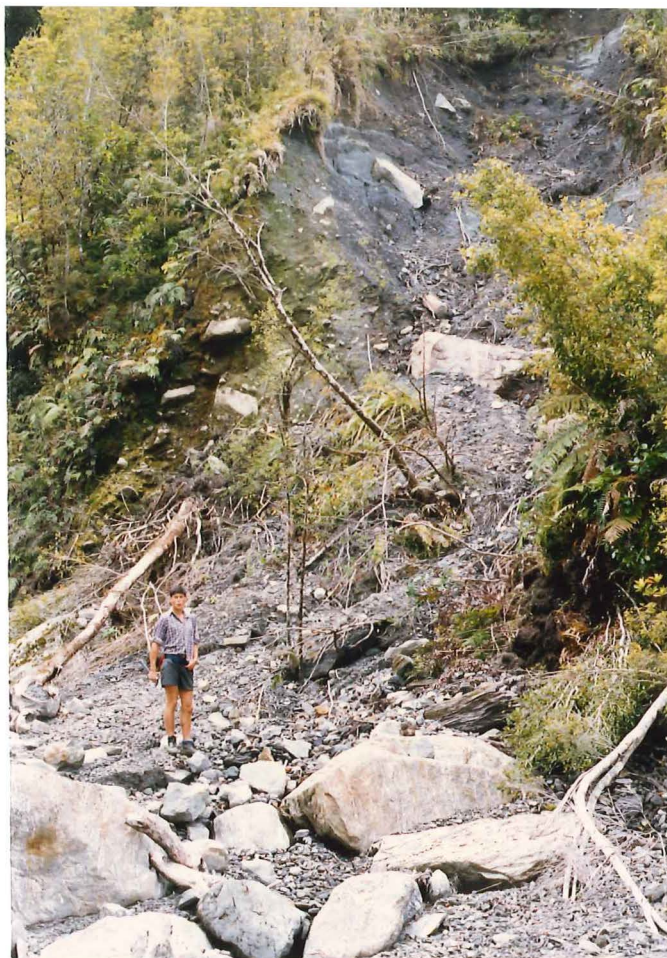
Where puggy tectonic breccia and fault gouge bedrock do form slope materials, as in Havelock Creek, these are prone to shallow debris slide and debris flow failure. Riparian puggy tectonic breccia slopes fail by shallow debris slide of the regolith/colluvium cover along the interface with underlying bedrock, exposing the weak fault zone material to post-failure gully erosion. In gully depressions, saturated puggy tectonic breccia and fault gouge bedrock may form debris flow failures (Fig. 5.22).

Fig. 5.22 Debris slide-flow in puggy tectonic breccia at Saltwater Creek.

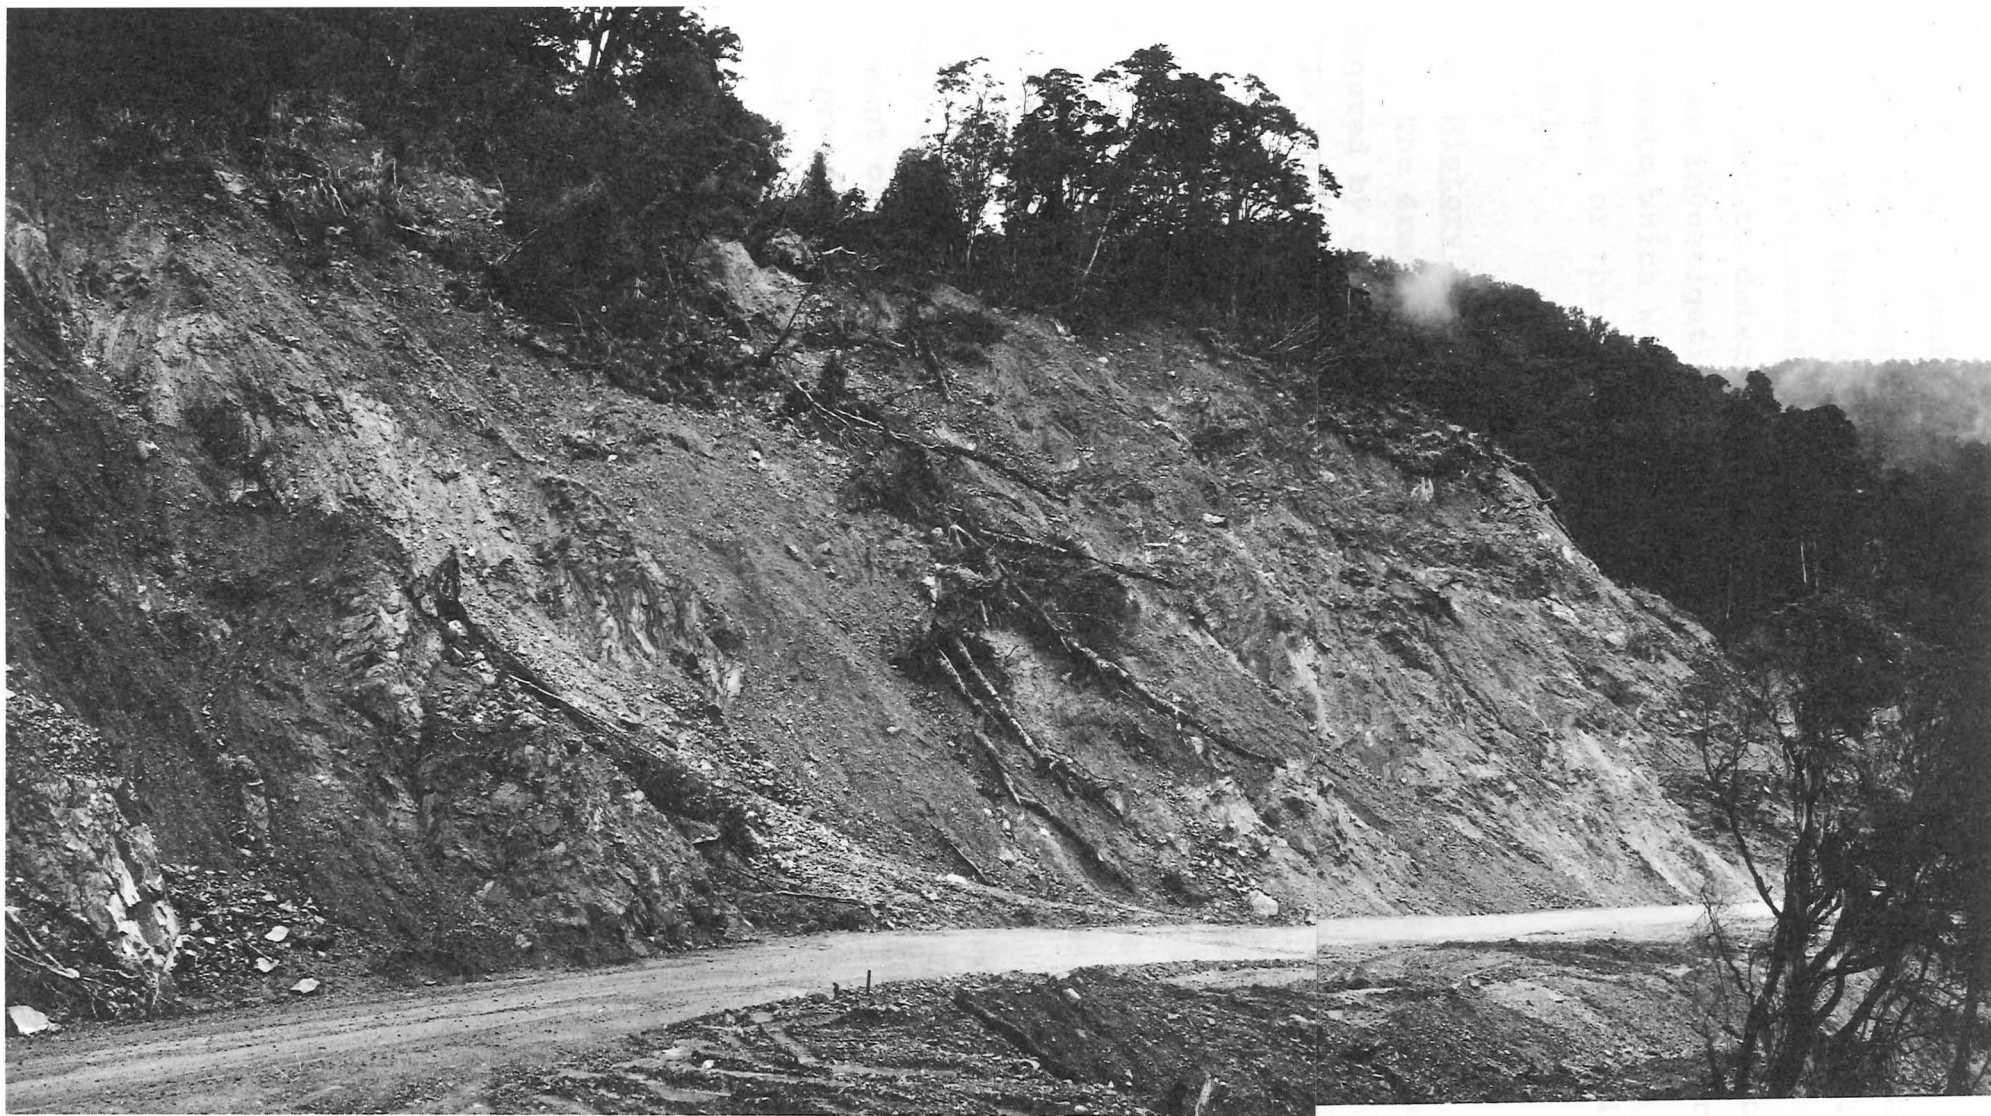
Fig. 6.3 Debris slide in sheared Greenland Group bedrock on eastern slopes above the Grave Creek culvert during construction of S.H.6 in 1963-1965 (from Young 1968).

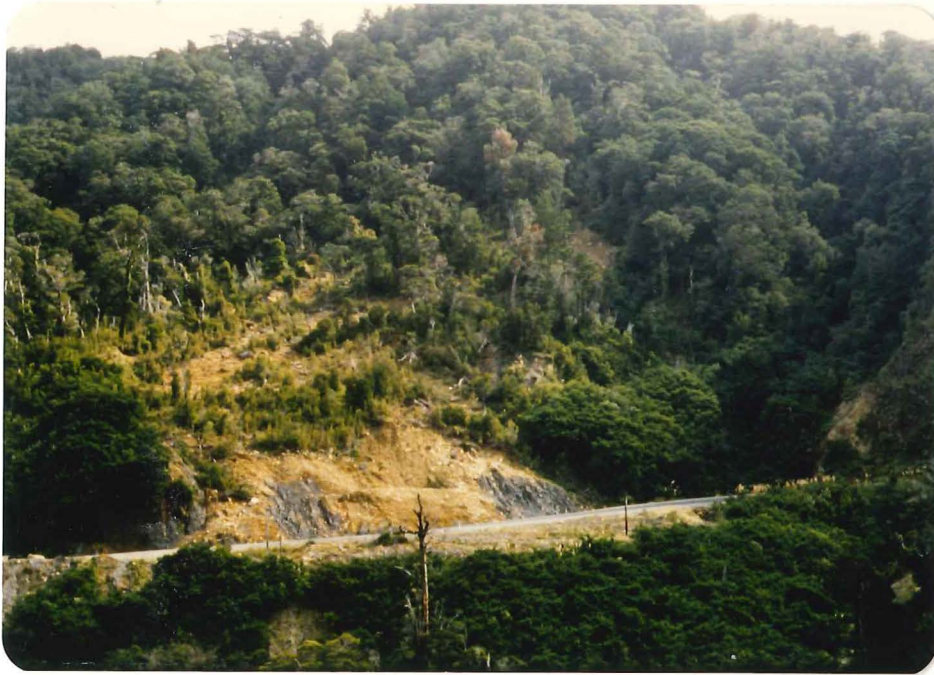
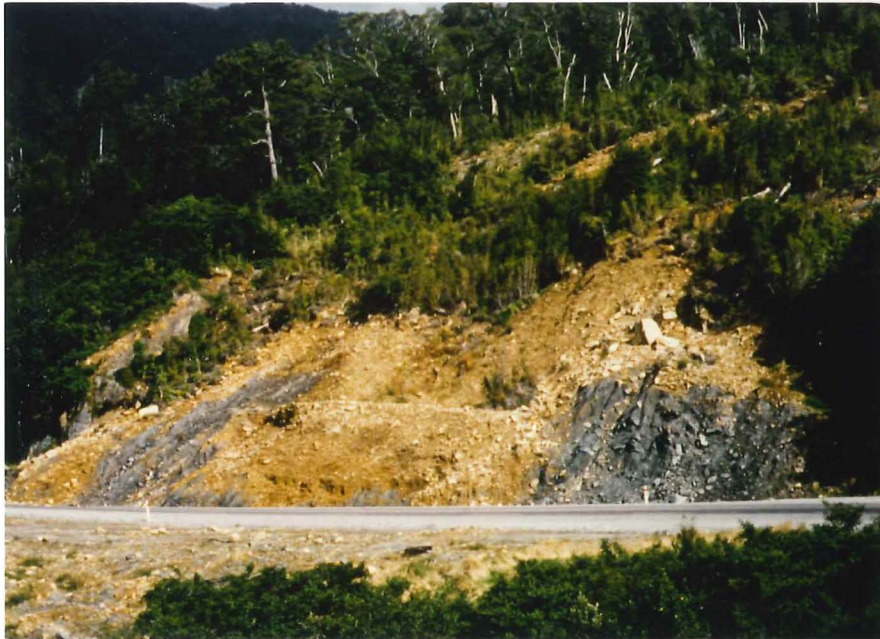
this catchment area has now been infilled with slide debris, and the Grave Earthflow is once again edging on to the road pavement surface (Fig. 6.6).

Fig. 6.6 Grave Earthflow in February 1986, 14 months after the road batter was cut and benched; the catchment area has infilled with debris and the toe of the flow is edging on to the road pavement surface. Note also the increase in bare ground since January 1985.

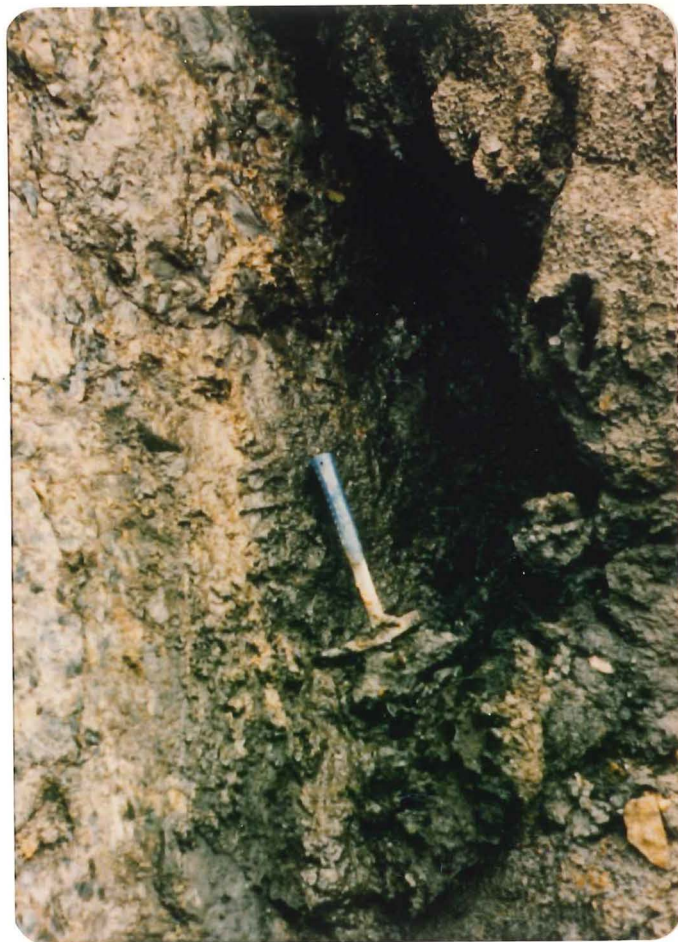
Two engineering soil deposits, associated with the earthflow, are derived from the two bedrock lithologies described above. An unweathered grey mud outcrops in the cut road batter at the toe of the earthflow and has been derived from shearing within lower Otumotu bedrock (Fig. 6.7): it is interpreted that this forms the zone within which basal sliding is taking place, thereby defining the surface of rupture. It is not known whether this grey mud is solely derived from fault pug material or also incorporates sheared material derived from slide movement of coal measures sandstone over lower Otumotu bedrock.

Fig. 6.7 Saturated grey mud in the east lateral shear zone, derived from intense shearing in lower Otumotu Formation bedrock.

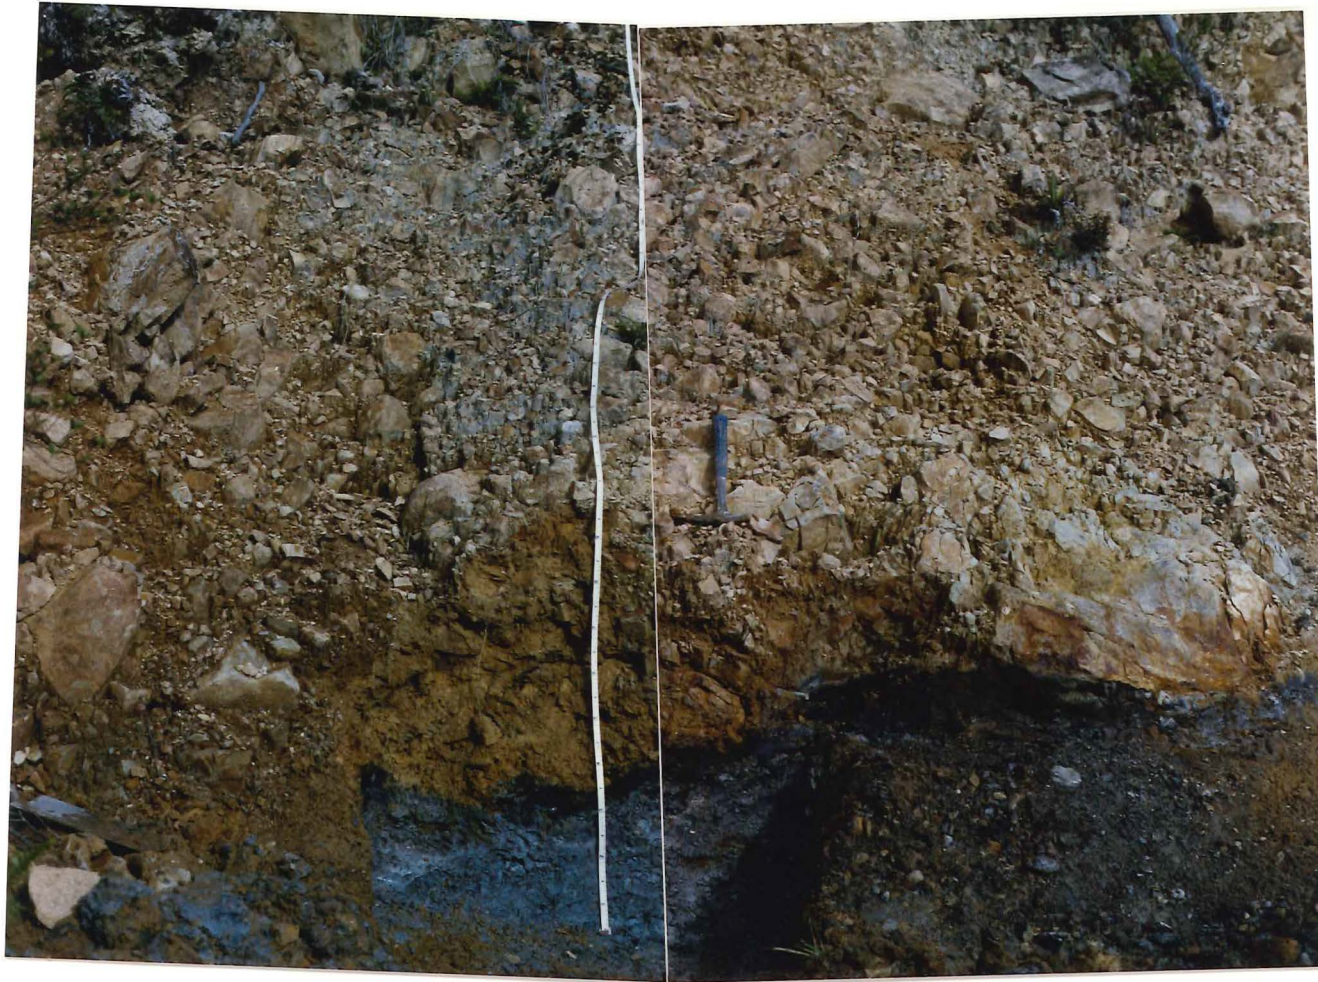
Fig. 6.12 Trial pit GEP 2: note the wet zone in yellowish brown gravelly sand slide deposit immediately above the band of black carbonaceous mud.

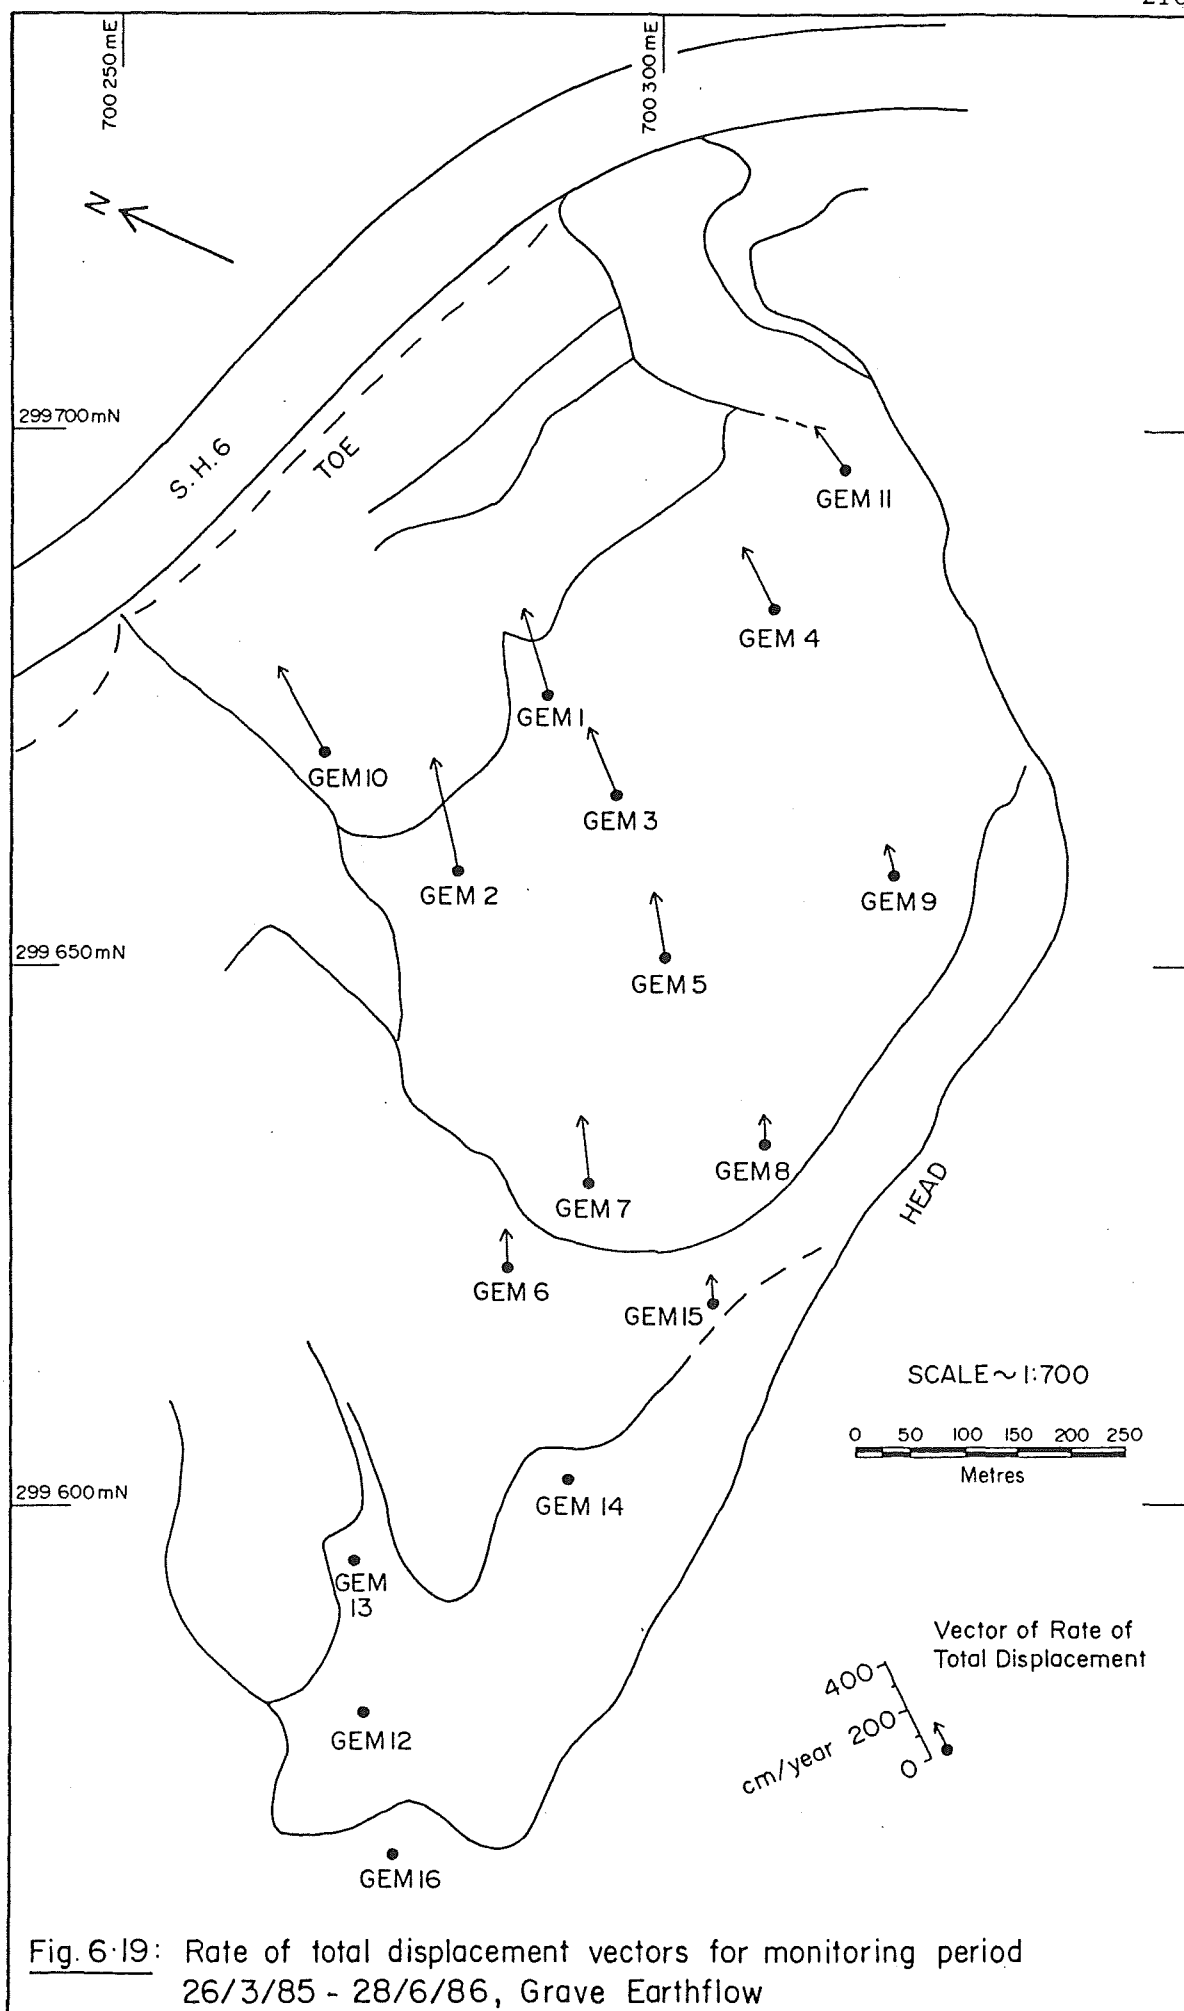
Table 6.3 lists the rate of total cumulative displacement for each monitoring station on the earthflow as measured during the monitoring period, and Figure 6.19 shows these data as vectors of rate of total cumulative displacement.

The greatest amount of movement was measured at the foot of the earthflow, with GEM 2 recording the highest total displacement rate of 419cm/year. This is a high movement rate producing substantial displacements at the toe of the earthflow and causing movement to extend on to the pavement surface of State Highway 6 during periods of heavy rainfall, which in turn provides continual maintenance problems. Rates of displacement decreased toward the head region of the active earthflow area, with GEM 8 recording the lowest of 108cm/year. Direction of displacement (Fig. 6.19) in the head area is east-northeast and this swings slightly to the northeast at the foot of the earthflow, which is directly downslope but acute to the aspect of the earthflow complex (north-northeast).

Beyond the active earthflow area, two monitoring stations (GEM 6 and GEM 15) also recorded movement. These are separated from the other monitoring stations in the main headscarp area (GEM 12,13,14) by a tension crack - scarp system along which the movement is inferred to be occurring. The one monitoring station (GEM 16) located outside of the earthflow complex above the main headscarp, recorded no movement.

Fig. 6.19: Rate of total displacement vectors for monitoring period 26/3/85 - 28/6/86, Grave Earthflow
